WING LEADING EDGE FUEL TANK IMPACT TESTS

National Aviation Facilities Experimental Center

Federal Aviation Administration

Report No. FAA-RD-72-83

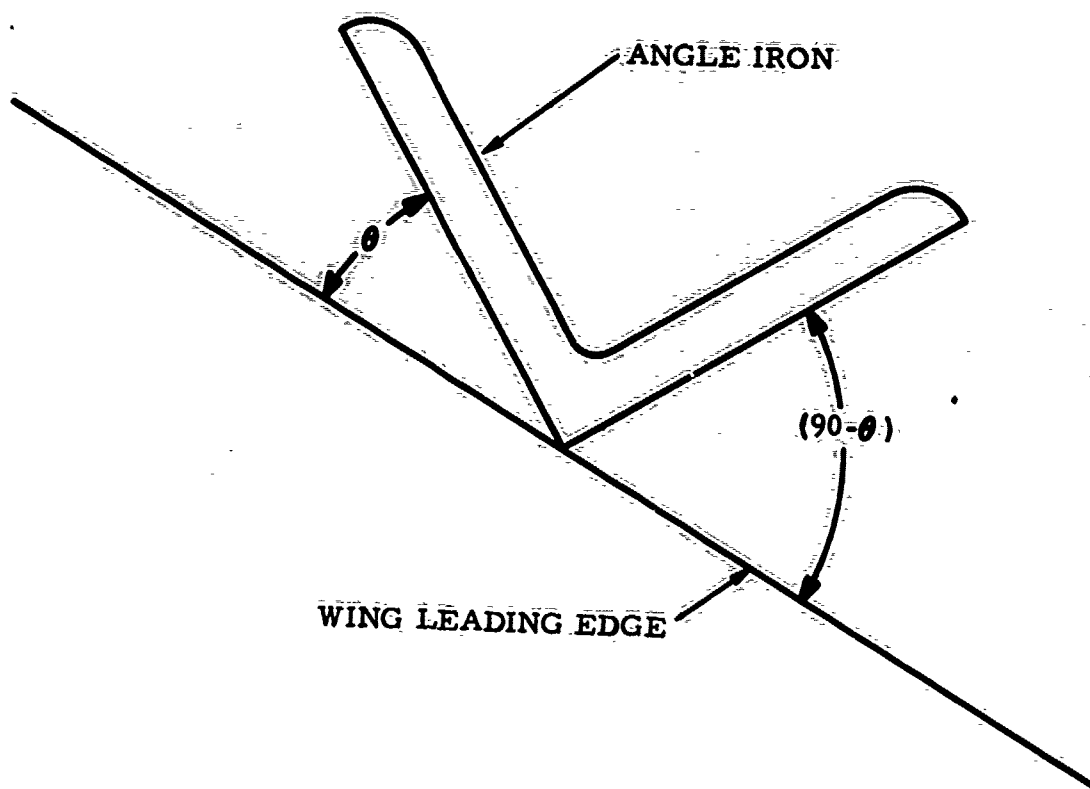
FIGURE 3. ANGLE OF IMPACT - ANGLE IRON TESTS

to consistently control its dimension and material specifications. However, the V-shaped cross section of the angle iron makes positive control at impact difficult. Referring to Figure 3, the angle of impact θ , may vary causing inconsistent test results. The most acceptable test obstacle was the pipe which, because of its cylindrical shape and conformance to a material specification, would be expected to produce quite consistent test results. The pipe used in this test program caused severe damage at approximately 100 mi/h. If this were considered too severe, the wall thickness of the pipe could always be decreased while keeping the outside diameter the same, thus reducing the severity of the test. The wall thickness of the pipe used was 0.203 inch, but tubing with the same outside diameter is available in wall thicknesses ranging from 0.049 to 0.750 inch. Also the pipe can be procured in a variety of diameters. However, for the same dimensions and material specifications, the variations in strength would be minimal for equal lengths of pipe, thereby imparting the same impact load for the same impact speed.

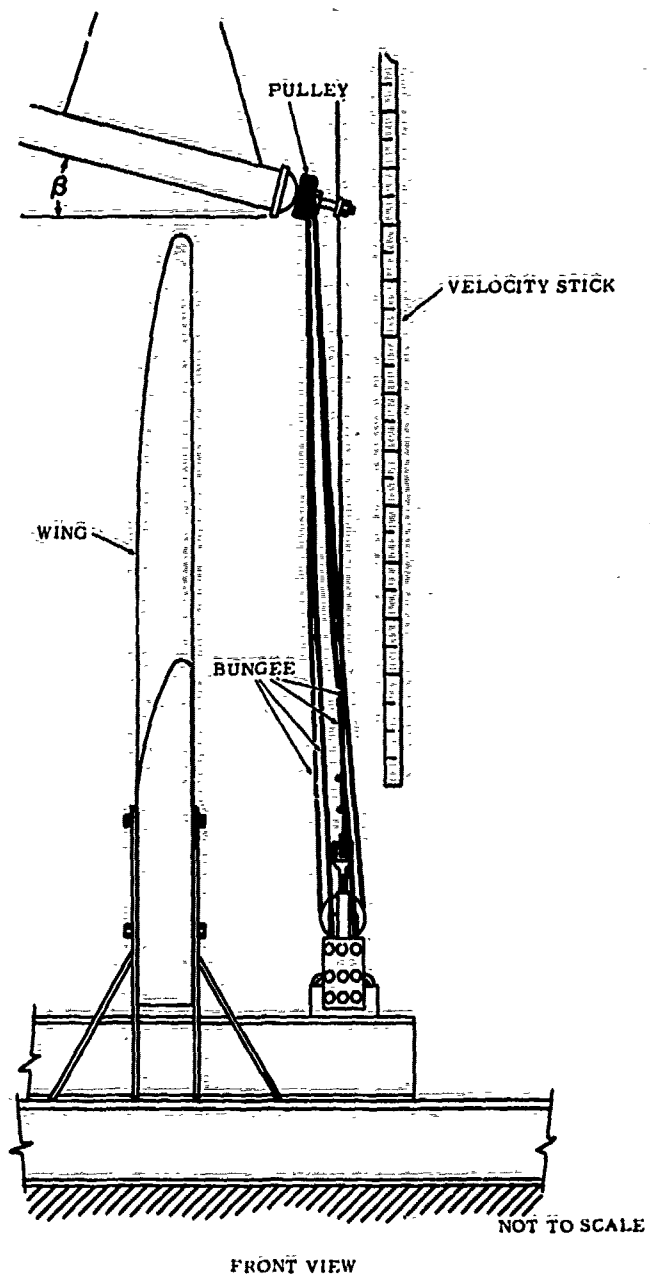
FIGURE 4. TEST OBSTACLE DURING ACCELERATION TOWARD WING

A relation of load (total downward force on obstacle at release) versus impact speed with the mass of the obstacle held constant was used to predict the impact speeds. This method of prediction was adversely affected by the tendency of the obstacle, as it accelerated toward the wing, to become other than horizontal causing the end fittings to bind with the guide cables which resulted in slower than predicted impact speeds. Table 2 (see page 10) shows the predicted impact speed and the actual impact speed. Figure 4 shows the obstacle in a position other than horizontal.

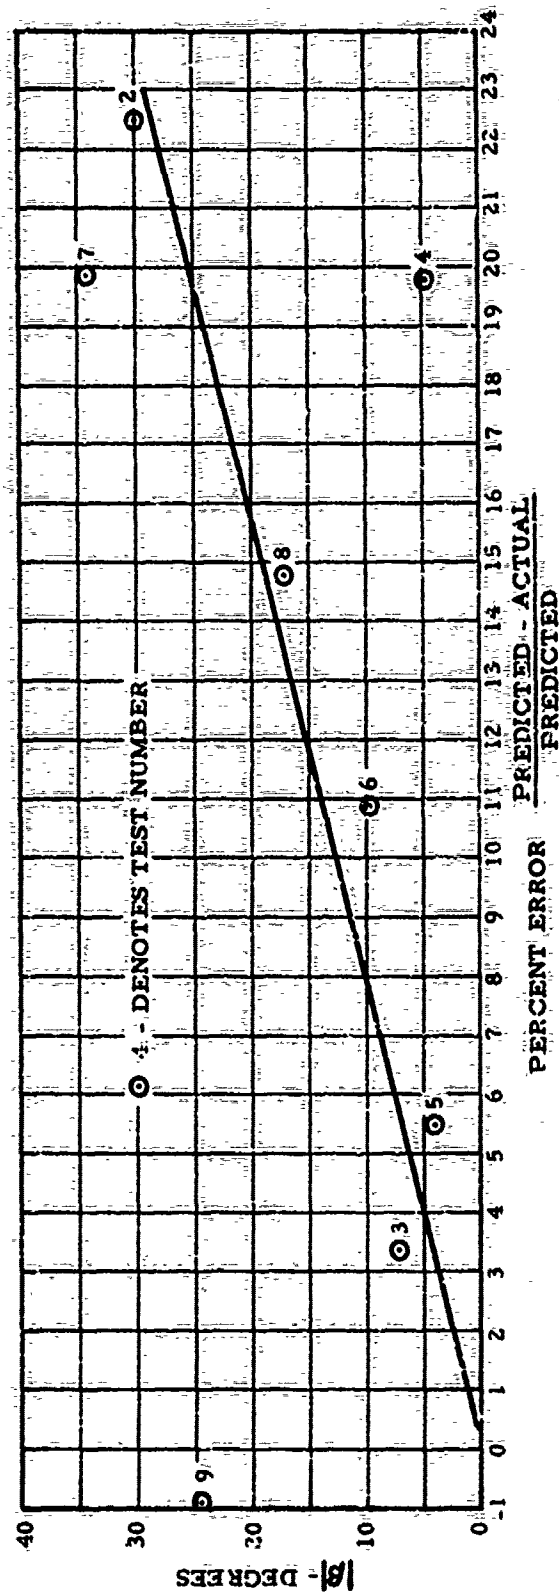
FIGURE 5: ANGLE OF IMPACT VS. PERCENT ERROR OF PREDICTED SPEED

Figure 5 was plotted using the high-speed film to determine the angle of the obstacle to the horizon (β) and using the percentage error between the predicted and actual impact speeds. The two tests which are not consistent with the others are Test 4 and Test 9. A likely explanation for Test 4 is that during the obstacle acceleration toward the wing one of the guide cables broke, there was no obvious explanation for Test 9 being inconsistent.

Figure 5 shows a possible correlation between the Angle β and the amount of error between predicted and actual impact speeds. This correlation indicates that the problem of speed control could be reduced if not overcome completely by reduction of the physical contact between the obstacle and the equipment to control the path of the obstacle before and during impact. Future testing of this type will be difficult unless this problem is resolved, because the test cannot be conducted with any reasonable expectation of what the impact speed will be.
